# Production Transfer of MSG Swing Motor to KHIZ on Installation of High-quality Assembly Line

UGAJIN Yuta

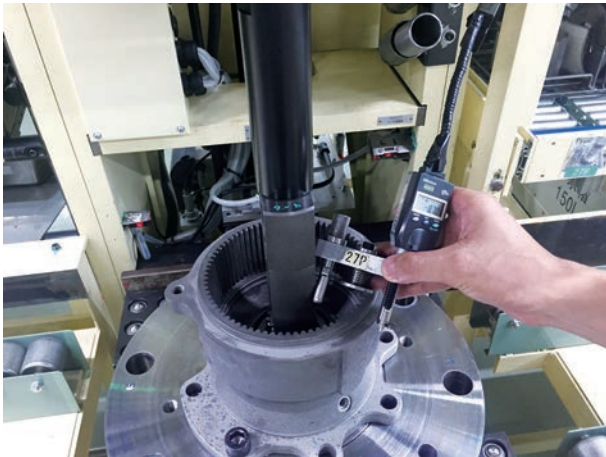
Photo 3 Clearance Measuring Apparatus

When the clearance determined by a measuring apparatus, was wirelessly transmitted (Photo 3), the indication lamp of a part box, in which appropriate shim is stored, illuminates (Photo 4). The system is designed to prevent a product from proceeding to the next step until an operator presses a picking sensor after picking out the specified shim.

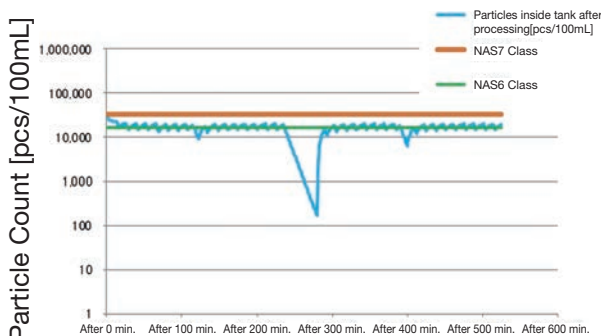
**Fig. 5** Simulator Output for Particle Count

A simulator which outputs the particle count inside the performance test tank upon entry of the required data, including filtration accuracy and pump flow rate, was internally developed this time (Fig. 5). The filtration accuracy and pump flow rate were determined by using this simulator in order to maintain the fluid cleanness level of the performance test equipment to be within our internal standard.

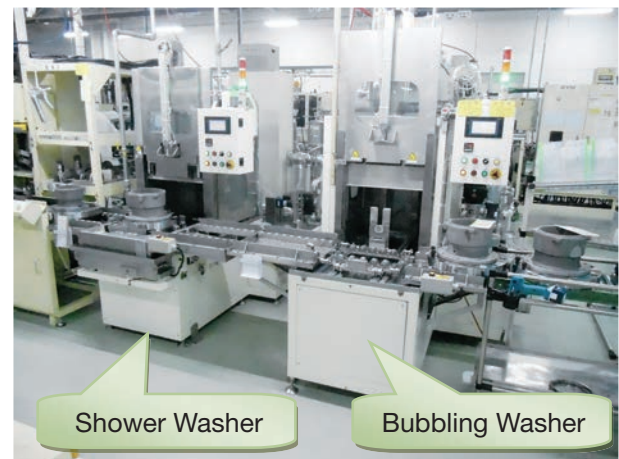
**Photo 6** Bubbling Washer Appearance

The low-cost bubbling washer was newly developed in order to keep expenses within investment budget (Photo 6). The previous bubbling washer requires two pumps, one for the circulation and the other for bubbling. This time, one pump can provide both the circulation and bubbling functions and successfully contribute to reduce the cost of equipment (Fig. 6). For further reduction of equipment cost, a local manufacturer in China was selected as a source of this washer.

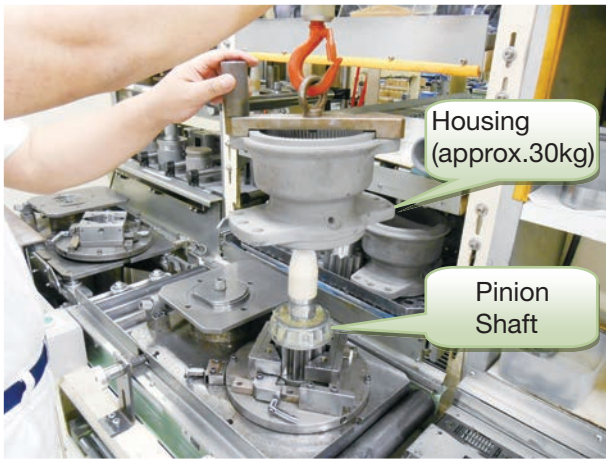
**Photo 7** Crane Operation

The previous preload control method requires a crane, which lifts a housing of mass approx. 30 kg. and place it on pinion shaft for installation (Photo 7). Use of crane was considered as one of hazardous work, in which materials falling or caught-in may occur.
