Launch of Takako Vietnam MMP Production Line

KAMIYA Hotaka, KAMENO Shota

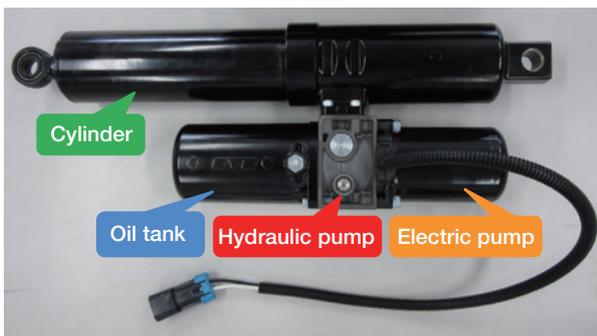
The mini motion package (hereinafter referred to as MMP) made at KYB Gifu East Plant is a compact electric hydraulic linear actuator in which an electric motor, hydraulic pump, oil tank, and cylinder are integrated (Photo 1).

Photo 1 Mini Motion Package (MMP)

MMP is mostly used as an actuator mounted on agriculture vehicles such as combines and pesticide spraying machines, and its major markets are Japan and North America.

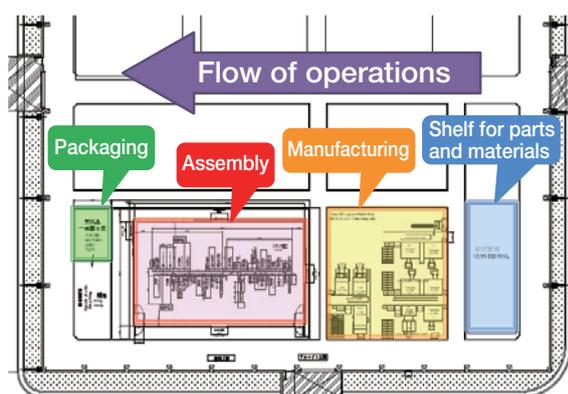
- ① Process that prevents defective products from being discharged even when unskilled operators are working (More mechanisms to prevent failure and avoidance of operations that rely on operator's intuition or short-cuts)
- ② Facility specifications with safety mechanisms to prevent disasters
- ③ Installation of the assembly line inside partitioned area with air conditioner to prevent contamination
- ④ Line layout that allows increase/decrease of operators depending on a change of production quantity
- ⑤ Making parts supply system for reduction of in-process inventory with physical distribution flow taken into account (Fig. 2)

Fig. 2 Factory layout

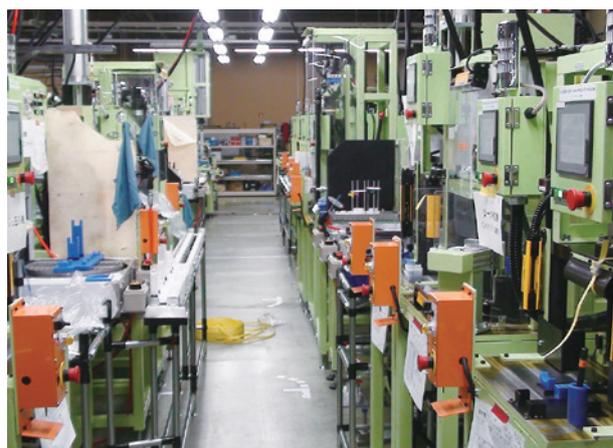
So, we launched the line and made an in-company audit of the production process in Japan before the shipment (Photo 3).

Photo 3 Launching of assembly line in Japan

For the process audit in Japan, the same requirements used for actual line launching were used. Evaluations of the following items was made.

- ① Does the production process secure the quality of products?
- ② Is there any problem in the quality of assembled prototypes?
- ③ Are the specifications required by TVC satisfied?
- ④ Are the facilities and production process safe?
- ⑤ Are a condition table and instruction manual available?
- ⑥ Are a parts-feed lane and tote box prepared?
- ⑦ Can the facilities be operated as designated in the instruction manual?

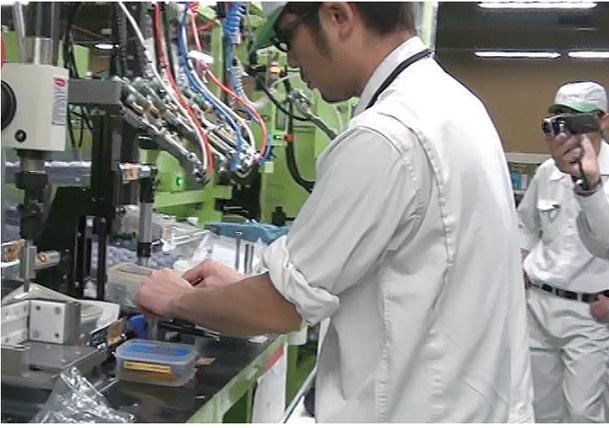
Photo 4 Check of line work

In the evaluation, performed together with staff from related divisions, prototype products were actually assembled in the developed line to find any problems in

each of the assembled products (Photo 4).

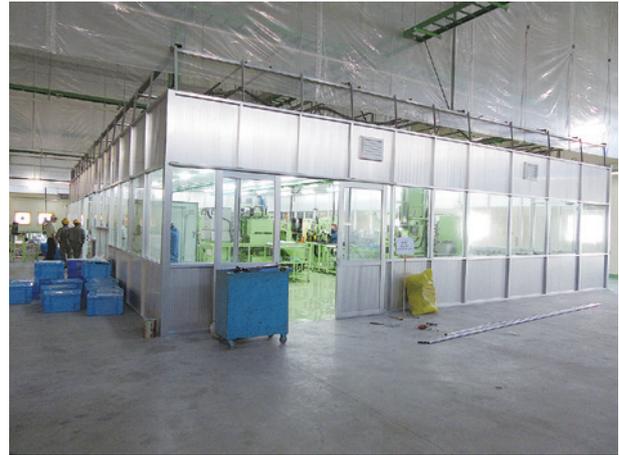
The local staff of TVC installed the facilities and partitions for air conditioning and connected the power supply and pneumatic source.

Directions given from Japan were only for the specifications, installation position, and installation height of the facilities and the local engineers were allowed to

Photo 5 Installation of assembly line

determine the details. The installation was completed successfully and the engineers seemed to get used to the installation of the facilities (Photo 5).

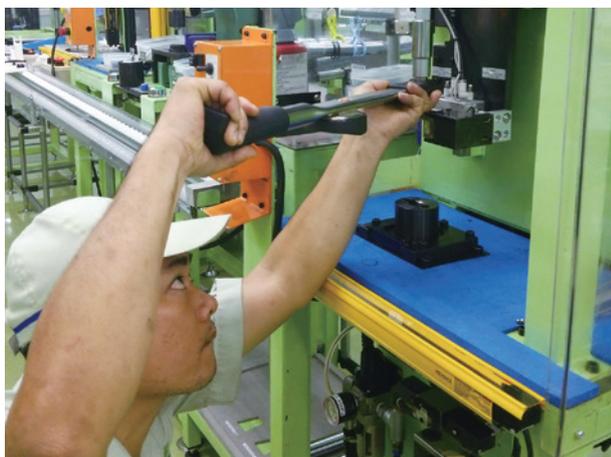
Photo 7 Training for facility inspection procedure

So, we issued a manual for facilities inspection and calibration steps and educated the TVC engineers (Photo 7).

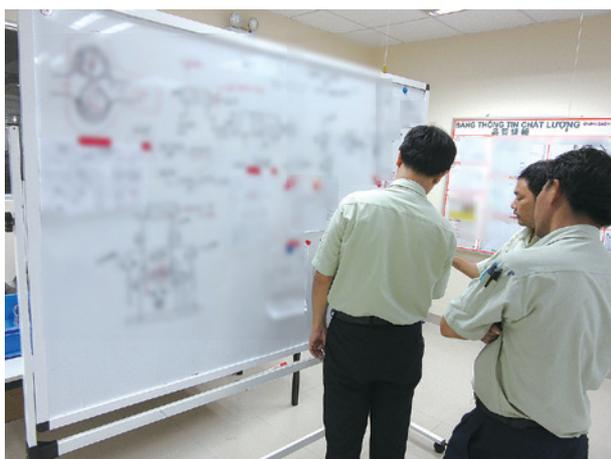
Photo 8 Explanation on MMP structure

So, we taught the engineers about the mechanism of MMP using drawings and hydraulic circuit diagrams and explained to them about how the products were used by end users, to let them realize the importance of the management items (Photo 8).

Also understanding the structure of MMP is necessary to grasp its production process. For example, when a non-standard MMP product is found in the performance test, one can identify the cause if he/she knows the product structure.

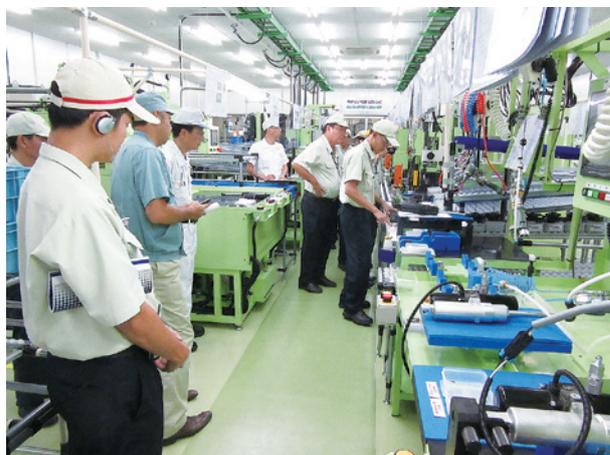
Photo 9 TVC's in-company check of the line

After the line construction, training, and production trials, an in-company examination was conducted by the quality assurance groups from Takako, TVC, and KYB (Photo 9).

The process audit had already been made in advance in Japan but the production line improvement was performed based on some comments from TVC and Takako. These comments were made because of incomplete prior agreement on the line specifications. This problem should be fixed in future.

There were also some comments on the processing ability of the parts and the worker education level. Because of the comments, the facilities failed to pass the examination. After countermeasures were taken, they finally passed the examination a week later.

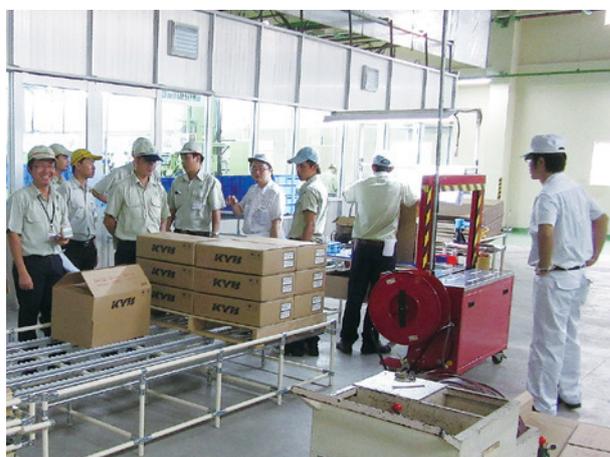
The MMPs produced at TVC are all exported to foreign countries. They are packed in a dedicated cardboard box and shipped from the board pallet (Photo 10).

Photo 10 Packaging and shipping of MMP

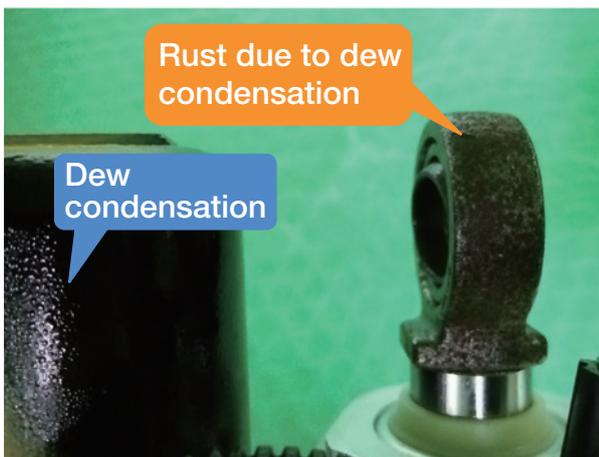
The air conditioner kept the temperature constant inside the partitions. However, workpieces and facilities in a place where cool air directly came from the air conditioner had dew condensation and parts with little rust resistance quickly became rusty (Photo 11).

Photo 11 Dew condensation and rust of workpiece

We therefore adjusted the temperature and wind direction of the air conditioner to prevent the workpieces from being cooled excessively. We also used heat insulating materials to cover the pipes.

These countermeasures prevented dew condensation and rust.

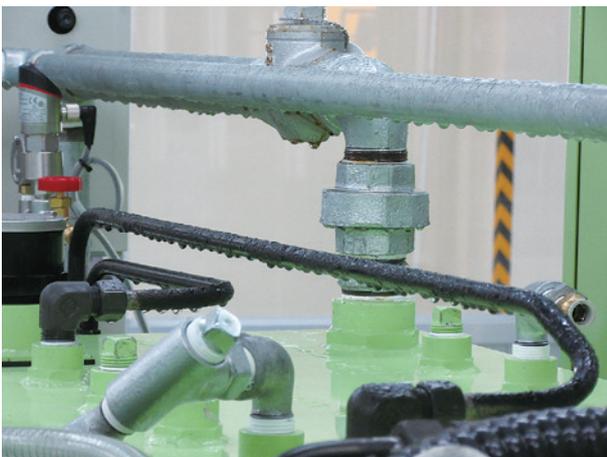
In particular, the temperature-controlled hydraulic oil pipes had significant dew condensation and even had water dripping from them (Photo 12).

Photo 12 Dew condensation of hydraulic pipe

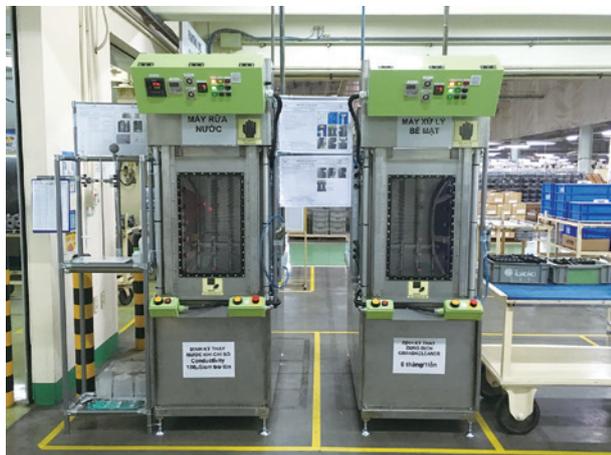
To maintain the paint quality after the discontinuance of the etching primer, a new cleaner was introduced for automatic pretreatment cleaning using an iron phosphate chemical conversion coating agent (hereinafter referred to as pretreatment agent). In order to maintain the painting quality even after the elimination of etching primer, a new cleaner was introduced to realize automatic pretreatment cleaning.

The cleaner was manufactured in Japan and installed at TVC after a paint test was made to check the quality (Photo 13).

Photo 13 Preprocessing cleaner (Right: Preprocessing, Left: Cleaning)
