Company name: KYB Corporation
Representative name: Yasusuke Nakajima, Representative
Director, Chairman and President Executive Officer

About nonconforming acts in the inspection process, etc. for seismic isolation/mitigation oil dampers for buildings manufactured by us and our subsidiary

Supplement Materials

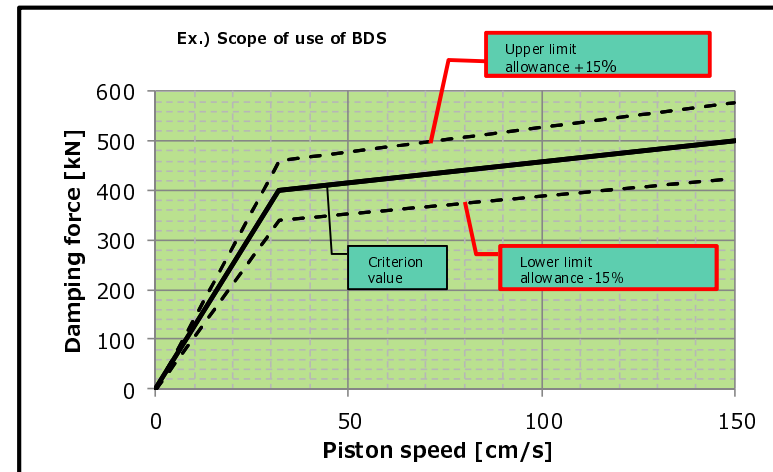
Seismic isolation oil dampers are certified as damping materials conforming to the Building Standards Act by the Minister of Land, Infrastructure and Transportation.

Damping performance of products certified by the Minister

: **Deviation of $\pm 15\%$ against the standard value is allowed.**

Damping performance as per contract with customer
: **Deviation of $\pm 10\%$ against standard value is promised.**

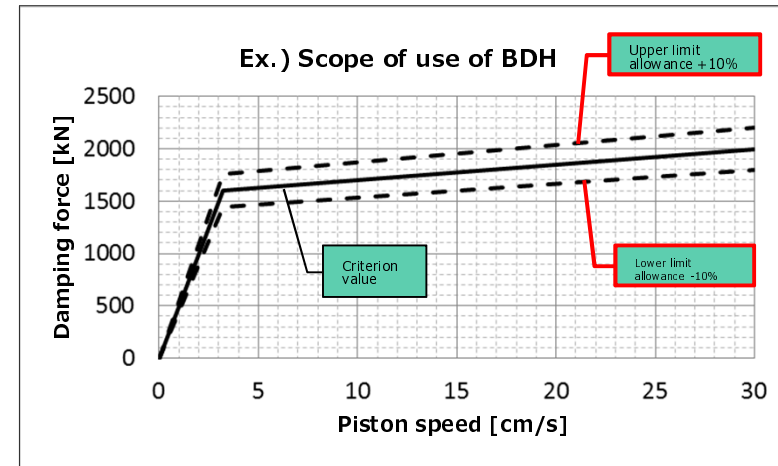
Standard values for damping performance of seismic mitigation oil dampers are determined by contracts with customers

Damping performance as per contract with customer
: **Deviation of $\pm 10\%$** against standard value is promised.

Our seismic mitigation oil dampers are **not certified by the Minister of Land, Infrastructure and Transportation.**

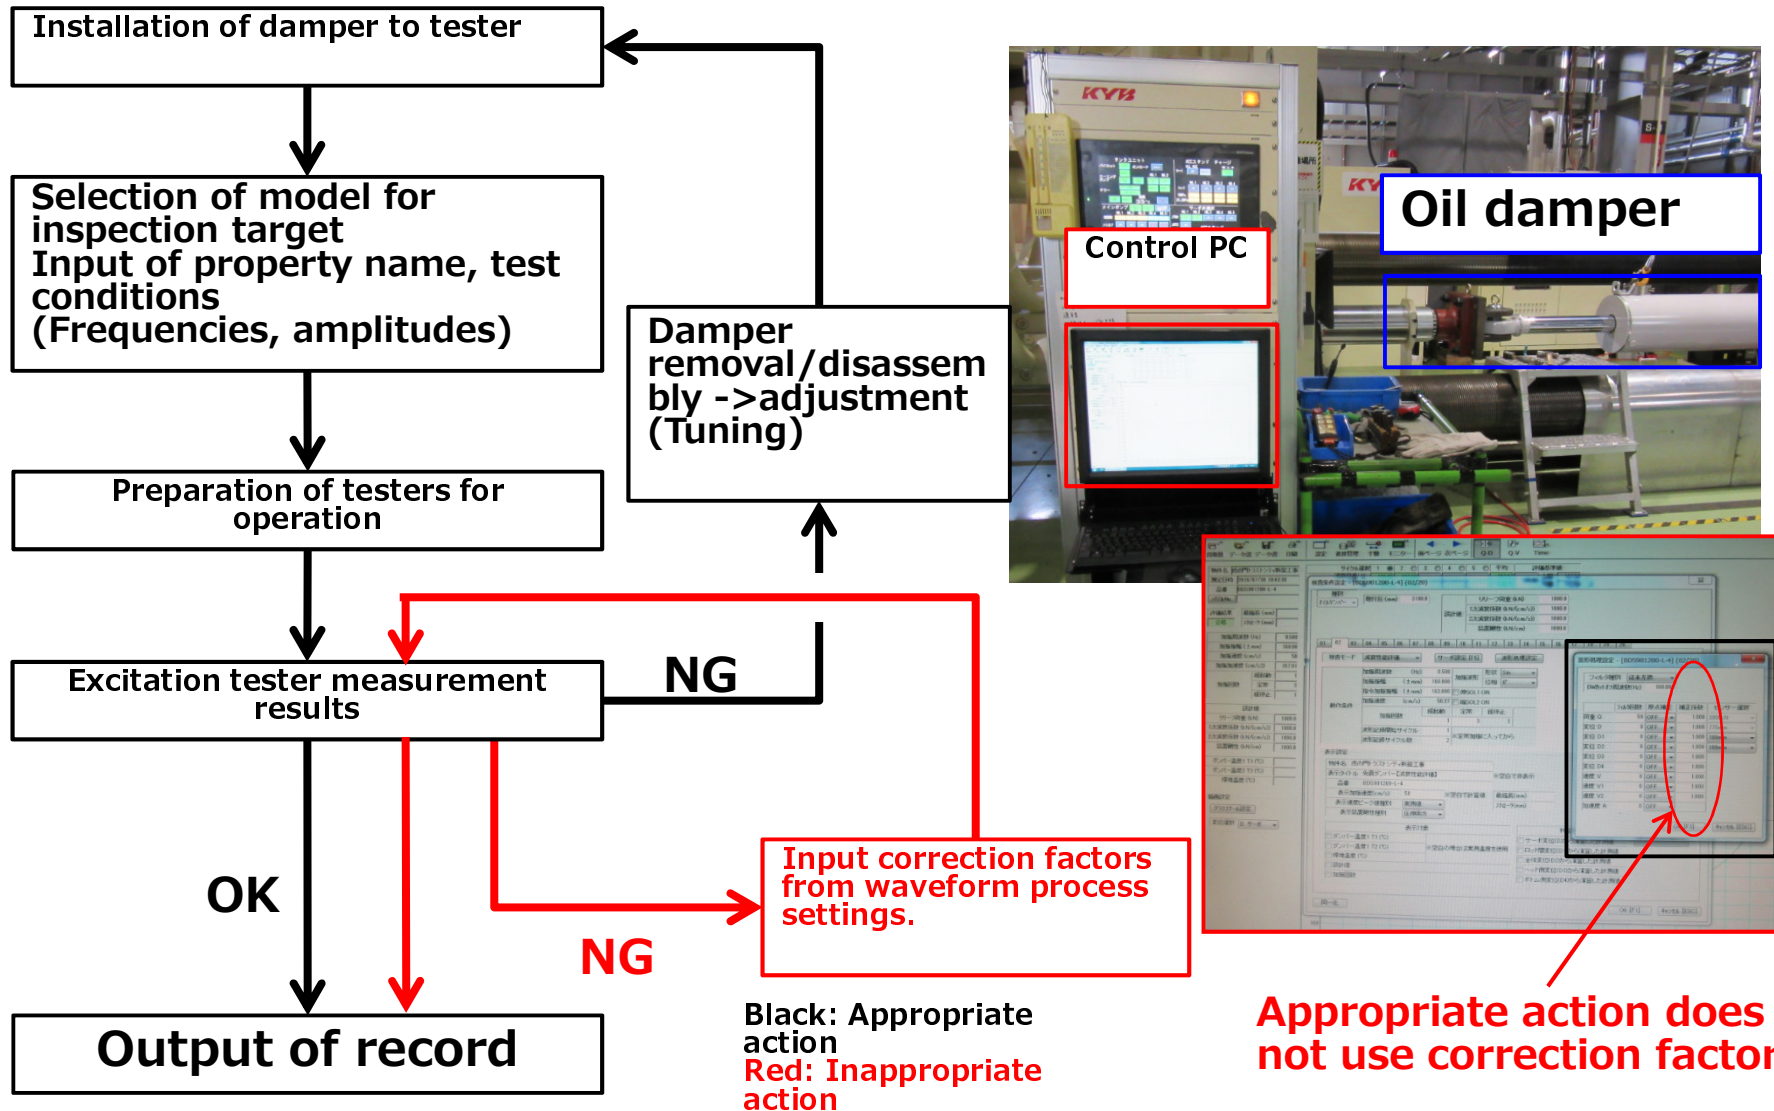
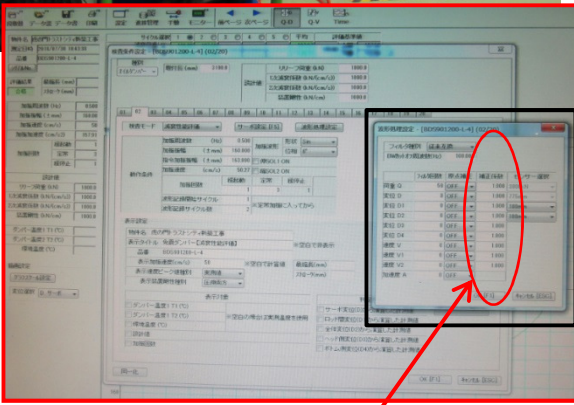
2. Details of falsification and process/inspection procedures
 2-3. Falsification of performance inspection record data

Appropriate action does not use correction factors.

- 1) Normal procedure: when data is outside the standard range in the performance inspection process, disassemble the product, and adjust it until the performance data falls within the range of standard values.
- 2) Falsification: values outside the standard range in the performance inspection process were falsified, and submitted as inspection records.

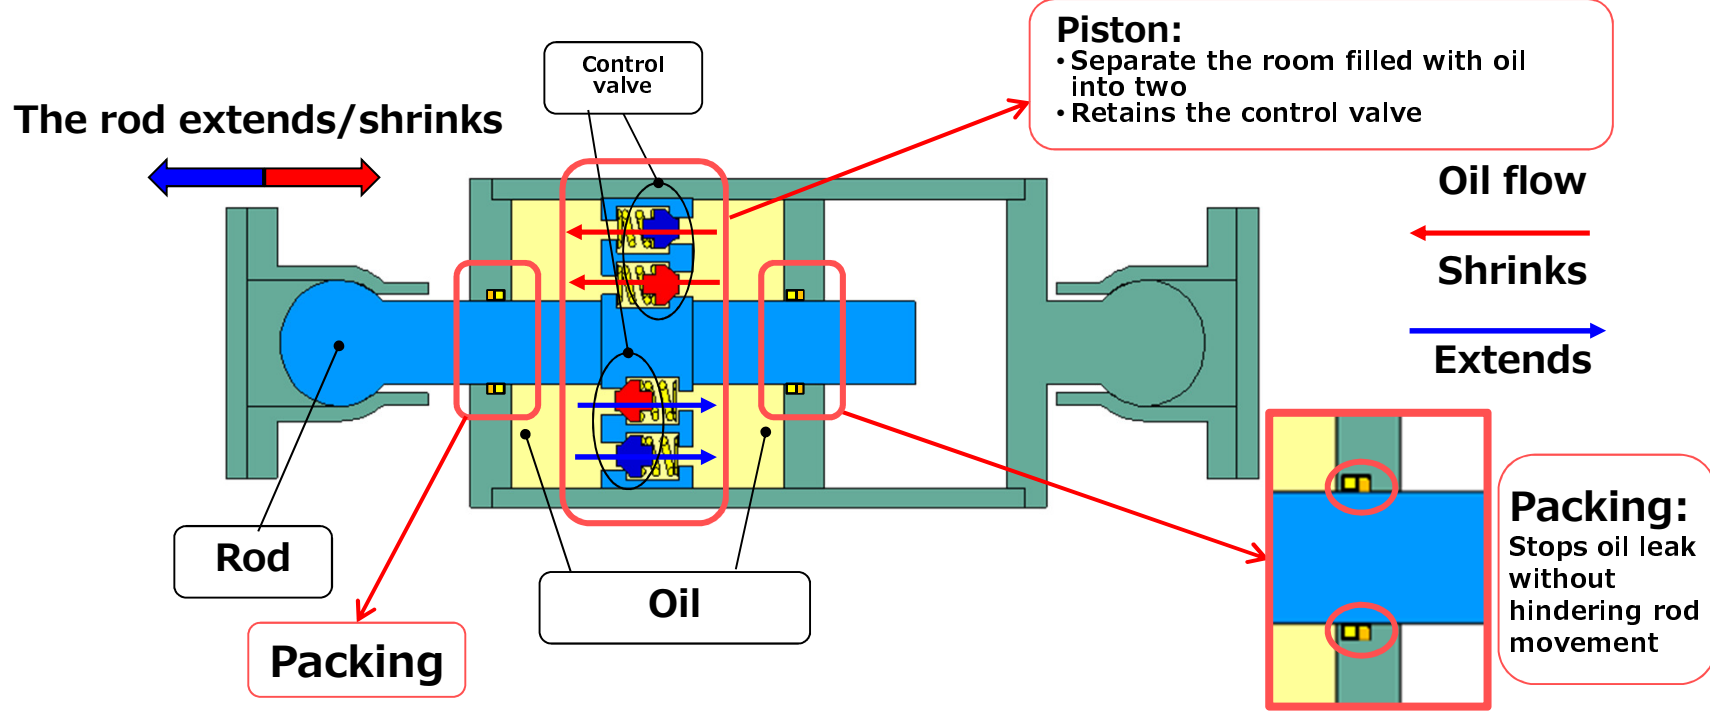
Reference: Structure and mechanism of oil damper

The mechanism of generating damping force of the oil damper is roughly stated below.
